CONVERTIBLE—TRIM FLIPPER DOOR BREAKS— REPLACEMENT PROCEDURE

Article No.
90-22-3

MERCURY: 1991 CAPRI

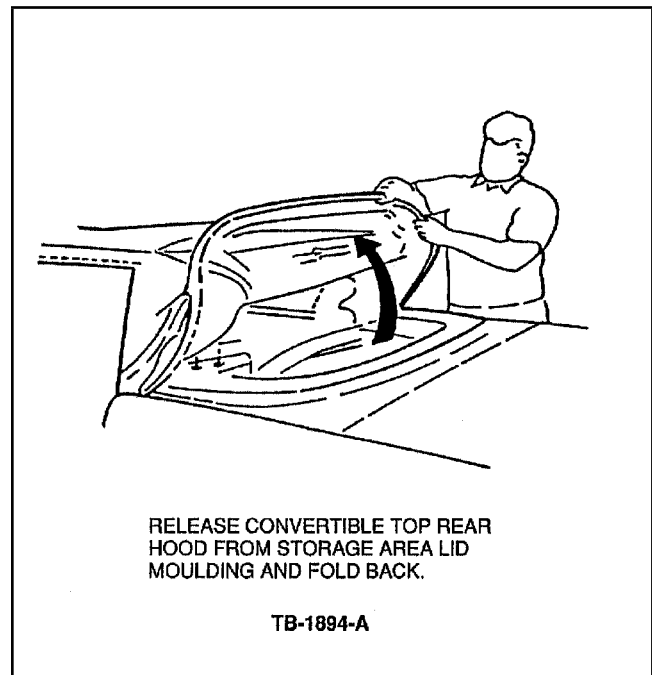
Figure 1 - Article 90-22-3

The trim flipper door on the rear storage cover is serviced as a separate item. It is not necessary to replace the entire trim storage cover in the event of a flipper door failure.

1. Release the convertible top rear hoop from the storage area lid moulding, Figure 1.
2. Remove the three (3) plastic cover plugs from the upper surface of the storage area lid trim panel.
3. Open the storage area lid and remove the nine (9) self tapping screws holding the trim panel to the storage area lid, Figure 2.
4. Remove the four (4) lid moulding retaining nuts from the left and right hand sides, Figure 2.
5. Loosen the moulding nuts along the lower edge, Figure 2.
6. Remove the lid trim panel.
