- **HESITATION—ON DRIVEAWAY—1.6L—AUTOMATIC TRANSMISSION**
- **STALL—ON “DRIVE” ENGAGEMENT—1.6L—AUTOMATIC TRANSMISSION**
- **STUMBLE—ON DRIVEAWAY OR TIP-IN—1.6L—MANUAL TRANSMISSION**

**Article No.
90-23-5**

LINCOLN-MERCURY: 1991 CAPRI

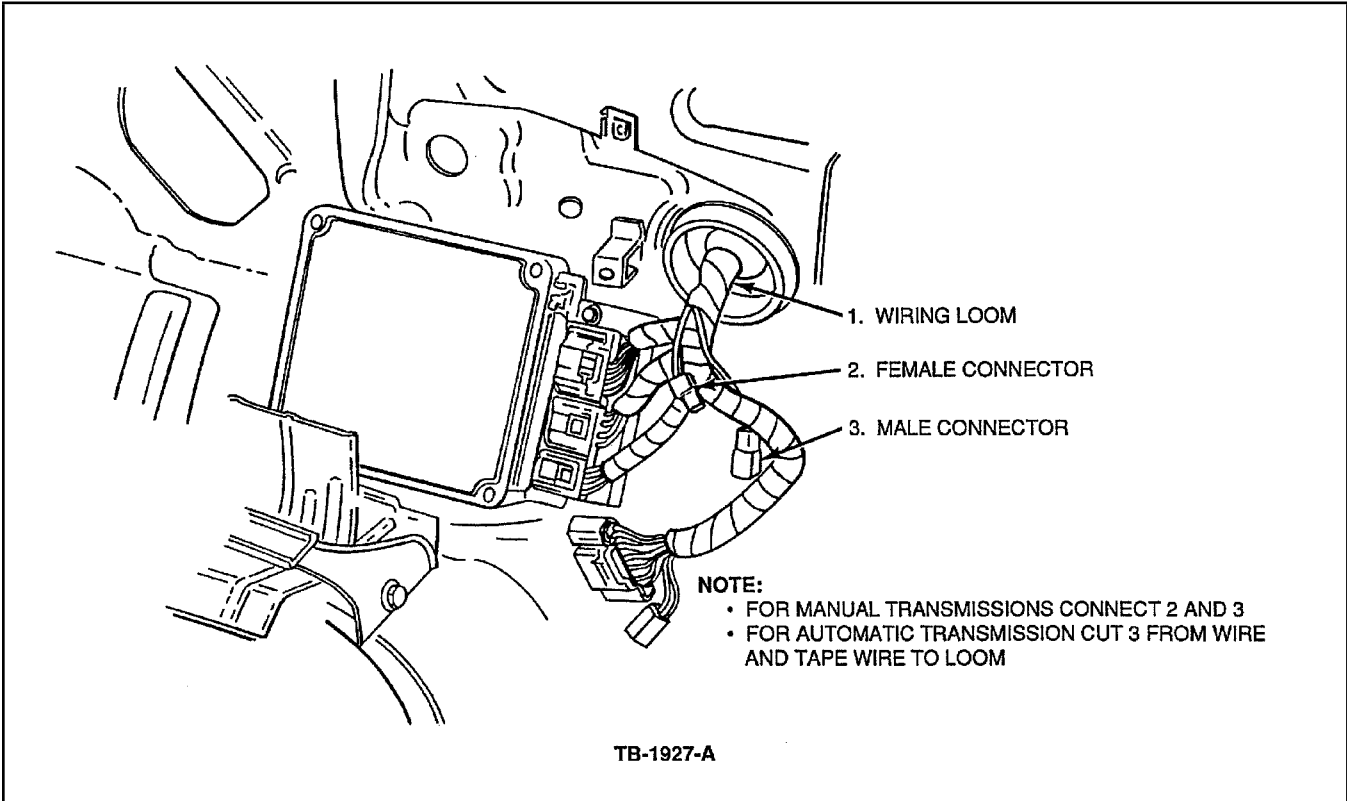
Figure 1 - Article 90-23-5

Hesitation, stall or stumble on “Drive” engagement or on driveaway may be caused by a poor connection at the 14401 and 12A522 wiring harnesses.

Check the wiring connections at the engine ECC processor, Figure 1. Refer to the following procedure for service details.

1. Remove the RH trim cover from the center console.
2. Make sure that the male and female connectors are connected, Figure 1.

1. Remove the RH trim cover from the center console.
2. Cut the male terminal from the wire.
3. Tape the cut end of the wire to the loom, Figure 1.
4. Tape the female terminal to the loom.
5. Install the RH trim cover on the center console.
