- **MIRRORS—OUTSIDE REAR VIEW—RATTLE OR VIBRATION**
- **NOISE—“RATTLE” OR VIBRATION FROM OUTSIDE REAR VIEW MIRRORS**

**Article No.
91-10-3**

MERCURY: 1991 CAPRI

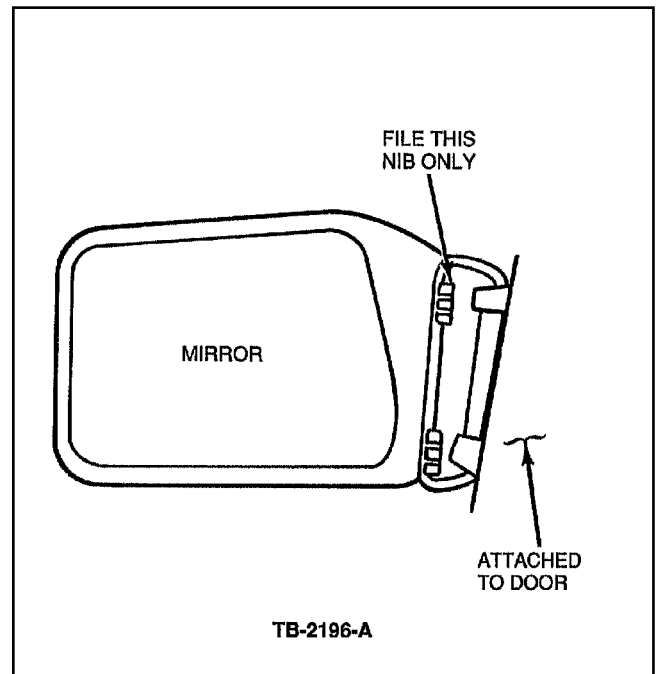
Figure 1 - Article 91-10-3

The outside rear view mirrors may rattle or vibrate. This occurs because the upper part of the rear location “nibs” do not allow a flush fit.

Modify the location “nibs” to permit a better fit. Refer to the following procedure for service details.

1. Inspect the mirror assembly by lightly pulling on the mirror head to see if it wobbles.
2. If the mirror head wobbles, pull the mirror head forward to expose the location “nibs”, Figure 1.
3. File the upper part of the rear location nib until the wobble is no longer apparent.

DO NOT REMOVE THE COMPLETE “NIB”. BE SURE THAT ONLY THE UPPER PART OF THE “NIB” IS FILED. TAKE CARE TO PROTECT THE MIRROR SURFACE FROM SCRATCHES.
