**STEERING—DRIFT OR PULL TO THE RIGHT—
VEHICLES WITH DUNLOP TIRES**

**Article No.
91-10-5**

MERCURY: 1991 CAPRI

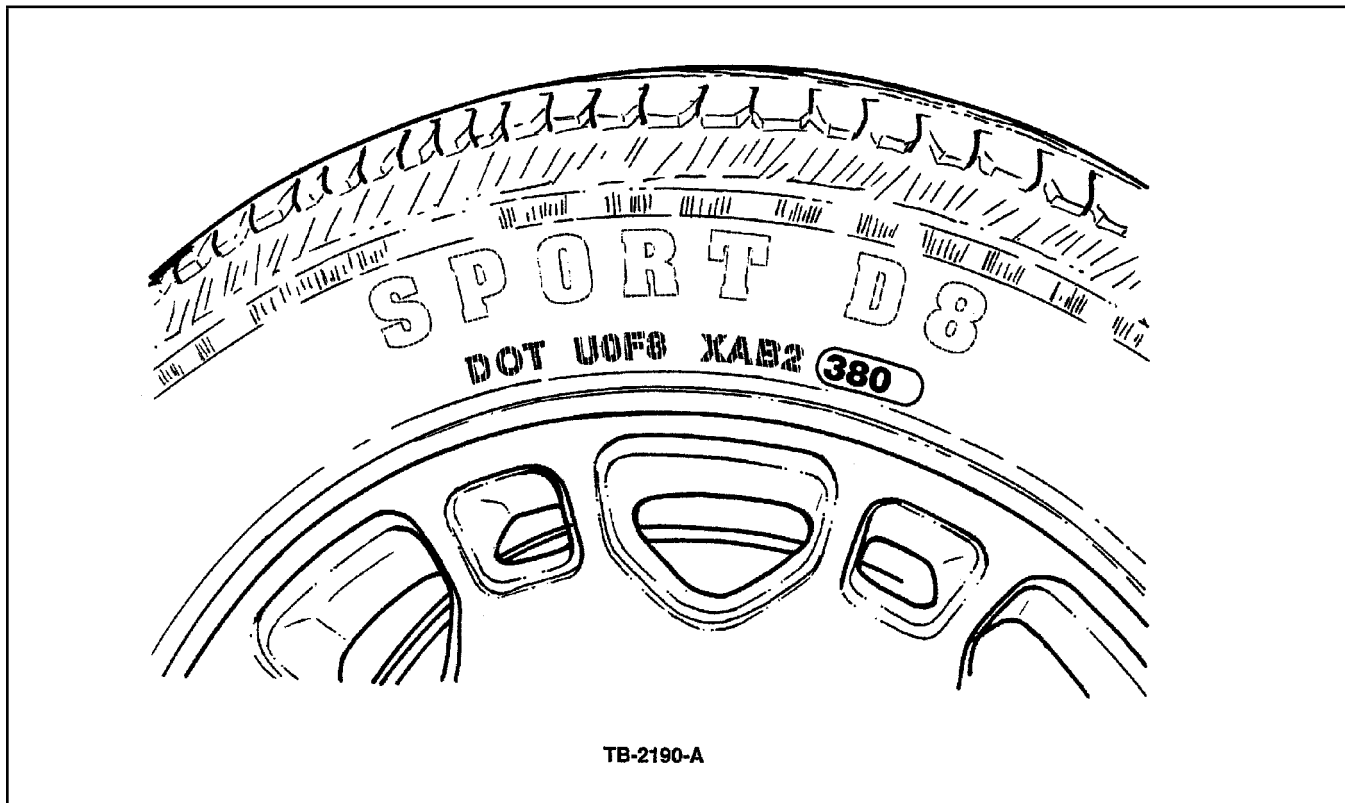
Figure 1 - Article 91-10-5

1. Check the 4-wheel alignment. If necessary, set to correct specifications as specified in TSB article 91-1-5.
2. Swap tire/wheel from the left side of car to the right side, one axle at a time, to identify if one tire is at fault. If one tire is at fault, replace it.
3. If the vehicle still drifts or pulls to the right, check the build dates on the tires, Figure 1. If the build date is 380 (38=week 38,0=1990) or earlier, replace all 4 tires with Dunlop tires built the week of 390 or later.
