- **GLASS—DOOR—WINDOW OPERATING MECHANISM—BINDING AND NOISY**
- **NOISE—“GRINDING AND CREAKING” SOUNDS FROM DOOR WINDOW MECHANISM**

**Article No.  
91-11-2**

**MERCURY: 1991 CAPRI**

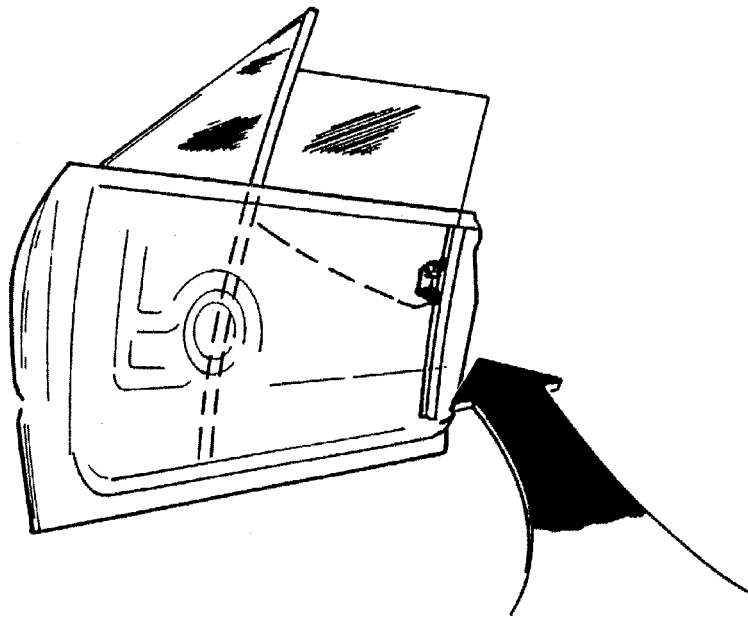
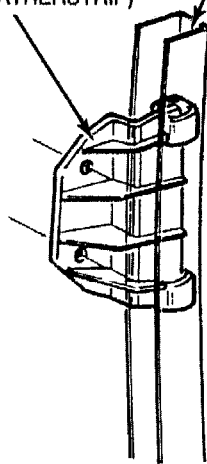
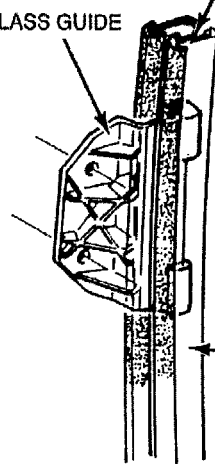
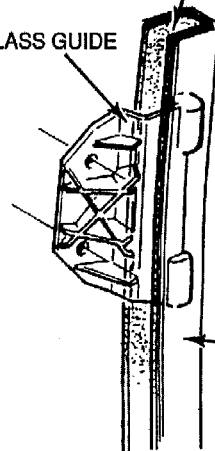
Figure 1 - Article 91-11-2

**THERE ARE THREE LEVELS OF GLASS GUIDE AND REAR GLASS RUN CHANNEL COMBINATIONS USED IN PRODUCTION. REFER TO FIGURE 1 TO IDENTIFY THE VEHICLE LEVEL.**

GLASS GUIDE  
(DISCARD AND REPLACE  
WITH LATE DESIGN GLASS  
GUIDE AND WEATHERSTRIP)

- a. If the vehicle has an early level glass guide and rear glass run channel, replace both components with the latest level components available.
  - b. If the glass guide and rear glass run channel are a later design level, modify the components as follows:

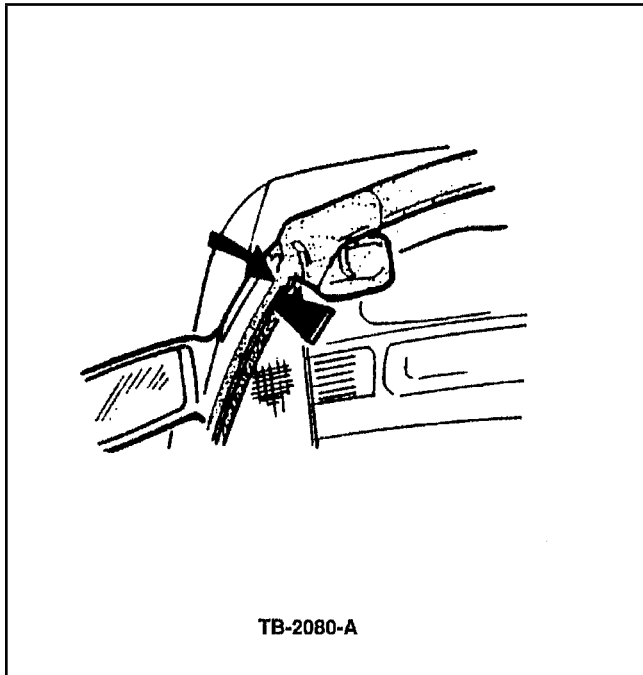
Figure 4 - Article 91-11-2

- d. If necessary, reduce the glass guide thickness up to 0.4mm to achieve a free sliding movement, Figure 3.
3. Inspect the door vertical division bar if the window glass will not fully raise. The end cap at the top of the division bar may be closed over, preventing the glass from raising. Proceed as follows:

- a. Lower the door glass.
    - b. Pull the weatherstrip aside at the top of the division bar.
    - c. Apply a coating of Weatherstrip & Rubber Adhesive (E8AZ-19552-A) to both sides after inserting the adhesive tube nozzle between the division bar and weatherstrip, Figure 4.

- d. Insert a wedge into the weatherstrip to ensure it is spread fully into the division bar channel.

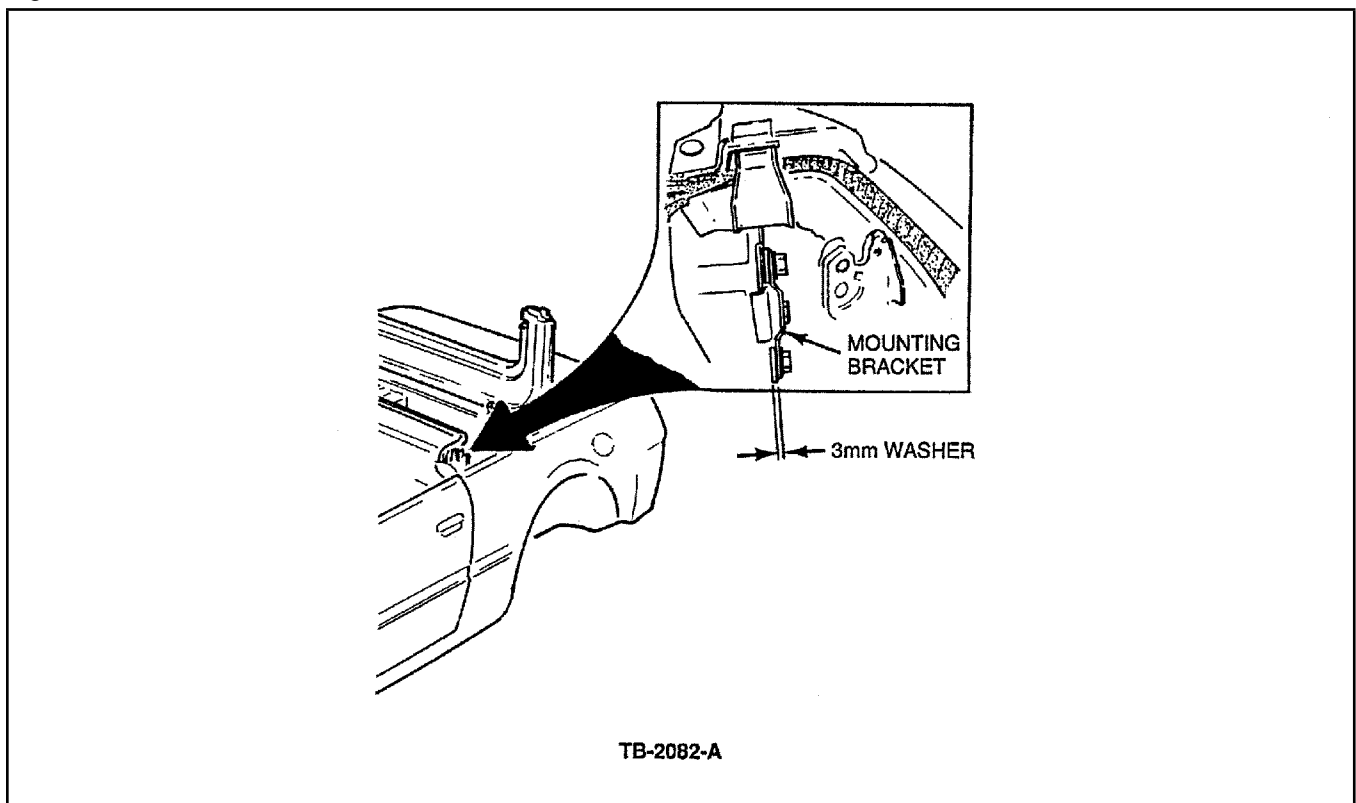
Figure 6 - Article 91-11-2

**THIS ACTION REDUCES THE FRAME WIDTH OF THE CONVERTIBLE TOP, PREVENTING EXCESSIVE LOADING FROM BEING APPLIED TO THE WINDOW GLASS.**

1. Check the LH door glass for excessive curvature at the rear edge.
  - a. Position 2 nuts from the retaining hardware on the door glass as shown in Figure 5.
  - b. Place a straight edge on top of the 2 nuts.
  - c. Measure the distance between the straight edge and the door glass upper surface.
    - The distance should be 8mm ±1mm.
    - If the distance is greater than 9mm, replace the door glass.
  - d. Install the door glass retaining hardware to the door glass.
  - e. Reassemble the door glass assembly to the door.
2. If the window glass winds up slowly with the door closed and faster with the door open, install 3.0mm thick shims between the soft top frame to body mounting points, Figure 6.
