**CONVERTIBLE—REAR WINDOW—SCRATCHED BY
THE REAR SEAT BACK LATCH**

**Article No.
91-20-3**

MERCURY: 1991 CAPRI

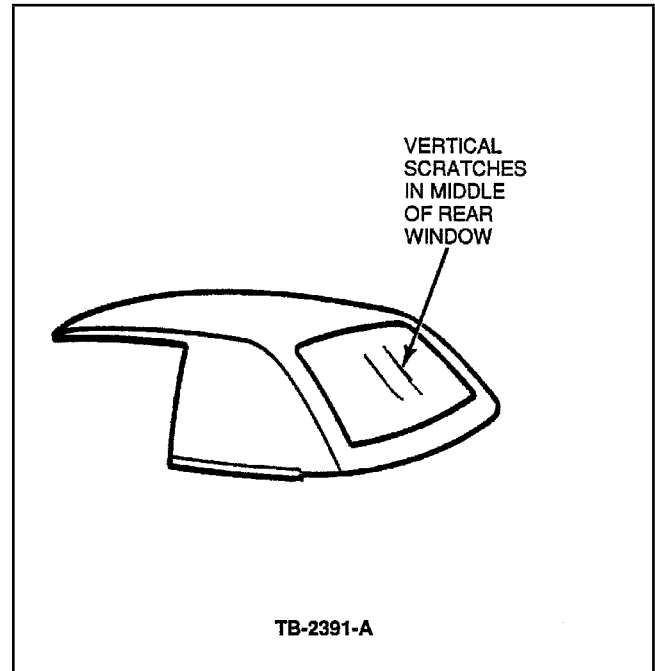
Figure 1 - Article 91-20-3

The rear window may be scratched when lowering the convertible top for stowage. This happens when the rear window passes the rear edge of the rear seat back latch.

Install three (3) protectors on the rear edge of the latch to prevent window scratches, Figure 1. Refer to the following procedure for service details.
