- **CONVERTIBLE TOP—INADEQUATE RETENTION OR DISLODGING OF THE TOP SIDE RETAINER**
- **CONVERTIBLE TOP—SIDES OF TOP LOOSE OR “BLOWS OUT”**

**Article No.
91-21-1**

MERCURY: 1991 CAPRI

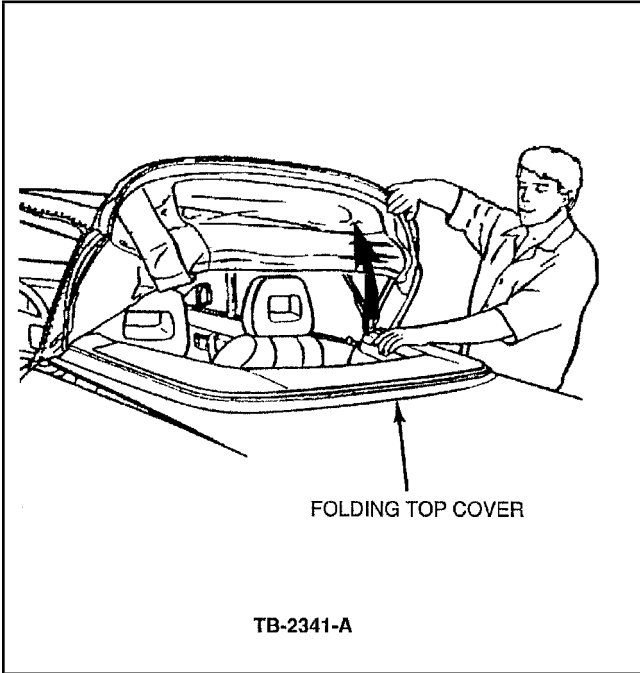
Figure 1 - Article 91-21-1

The convertible top sides may appear to be loose or “blown out”. This is caused by inadequate retention or dislodging of the convertible top side retainer.

1. Raise the rear of the convertible top, Figure 1. Refer to the Owner Guide for detailed procedures.
