- **AIR CONDITIONING—DEALER INSTALLED—FAN POWER LEAD WIRE “RELOCATION”**
- **FAN—AIR CONDITIONING—DEALER INSTALLED—RELOCATION OF POWER LEAD WIRE**
- **WIRING—AIR CONDITIONING—DEALER INSTALLED—PUSHER FAN POWER LEAD “RELOCATION”**

**Article No.
91-24-9**

MERCURY: 1991 CAPRI

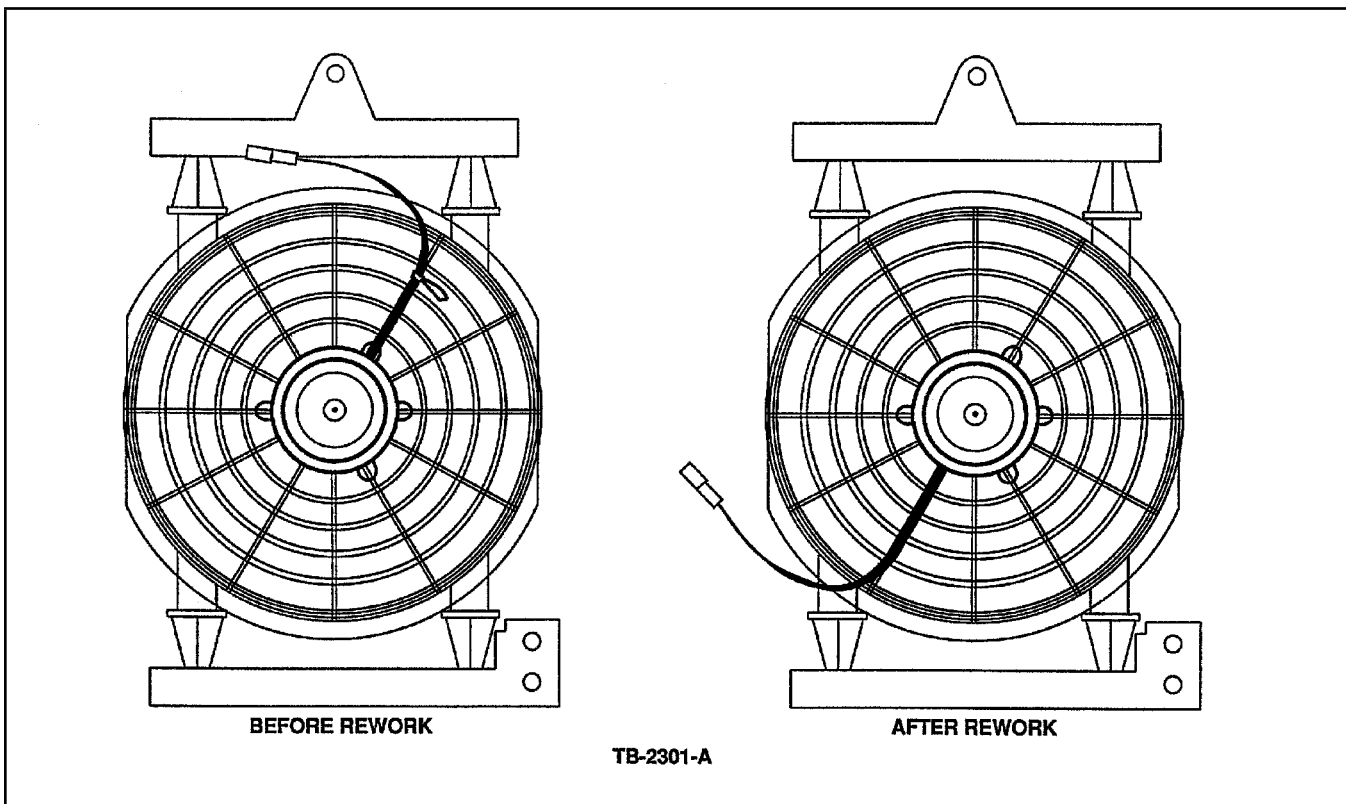
Figure 1 - Article 91-24-9

Dealer installed air conditioning kits purchased before 5/31/91 contained pusher fans with the power lead in the 1 o'clock position. In this position the fan motor may fill with water.

Relocation of the power lead to the 7 o'clock position will be necessary to ensure that the fan motor will not fill with water. Relocation can be obtained by removing and repositioning the fan or by replacing the fan with a new fan with the wires in the 7 o'clock position. Refer to the following procedure for service details.

1. Cut the cable tie holding the fan motor leads in place and discard the cable tie.
2. Remove the (2) bolts securing the motor to the fan shroud.
3. Rotate the motor 180 degrees so that the leads are in the 7 o'clock position. Refer to Figure 1.
4. Replace the (2) bolts securing the motor to the fan.
5. Manually spin the fan blades to insure that the motor does not contact the shroud.

9. Replace the fan if it is inoperative. If the fan was operational rework the fan by;
 - a. Clipping the cable tie holding the leads to the fan shroud and discard.
 - b. Remove the bolts (2) that hold the fan to the shroud, save the (2) screws for reinstallation.
 - c. Rotate the fan motor 180 degrees so that the motor leads are in the 7 o'clock position, Refer to Figure 1.
 - d. Replace the (2) bolts securing the motor to the shroud.
