- **LEAKS—WATER—THROUGH HEATER AIR INTAKE DUCT ON PASSENGER SIDE**
- **HEATER—WATER LEAK THROUGH AIR INTAKE DUCT ON PASSENGER SIDE**

**Article No.
92-11-5**

MERCURY: 1991 CAPRI

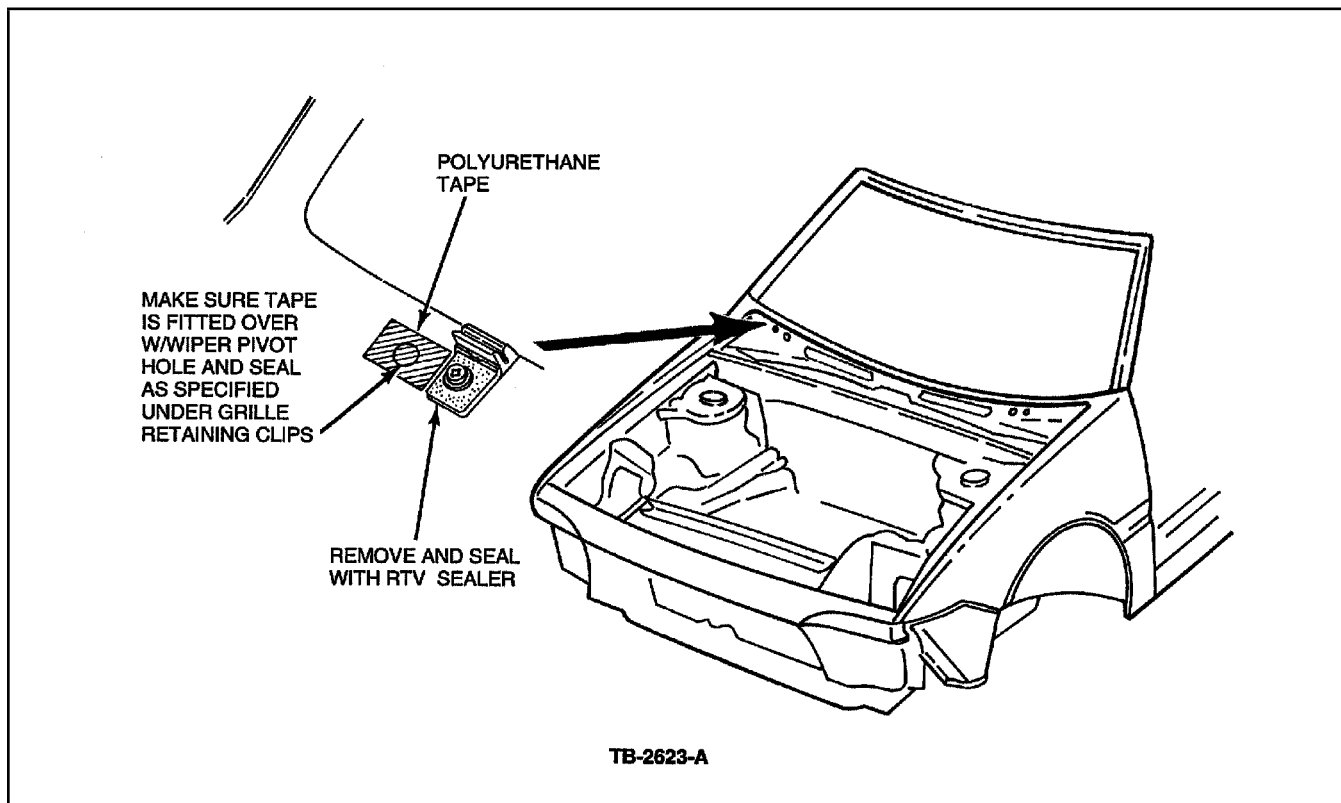
Figure 1 - Article 92-11-5

Water may leak through the heater air intake duct on the passenger side. When the blower motor is in the high position, water may enter the vehicle through the plenum chamber or behind the instrument cluster and get the passenger side wet. This occurs because an unused windshield wiper pivot hole on the right hand side of the vehicle was not properly sealed.

1. Remove both windshield wipers. Refer to the 1991 Capri Service Manual, Section 35-60, for the removal procedure.
2. Remove the lower windscreen moulding. Refer to the 1991 Capri Service Manual, Section 43-02, for removal details.
3. Inspect for clear polyurethane tape covering the unused windscreen wiper pivot hole, Figure 1.
4. If the polyurethane tape is missing, proceed as follows:
 - a. Clean and dry the area.

Seal the open windshield wiper pivot hole with polyurethane tape. Refer to the following procedure for service details.

- b. Install new polyurethane tape (FOJY-76021-A46A), Figure 1.

5. Remove the windshield retaining block closest to the pivot hole, Figure 1.
6. Seal this area with RTV silicone sealer (D6AZ-19562-BA), Figure 1.
7. Replace the screw and windshield retaining block.
8. Reinstall the lower windscreen moulding.
