- **ALTERNATOR—REPETITIVE DRIVE BELT FAILURES—VEHICLES BUILT FROM 2/11/91 TO 1/28/92**
- **BATTERY—DISCHARGED—CHARGE INDICATOR LAMP LIT—VEHICLES BUILT FROM 2/11/91 TO 1/28/92**
- **ACCESSORY DRIVE BELT—1.6L—REPETITIVE FAILURES—VEHICLES BUILT FROM 2/11/91 TO 1/28/92**

**Article No.
92-6-10**

MERCURY: 1991-1992 CAPRI

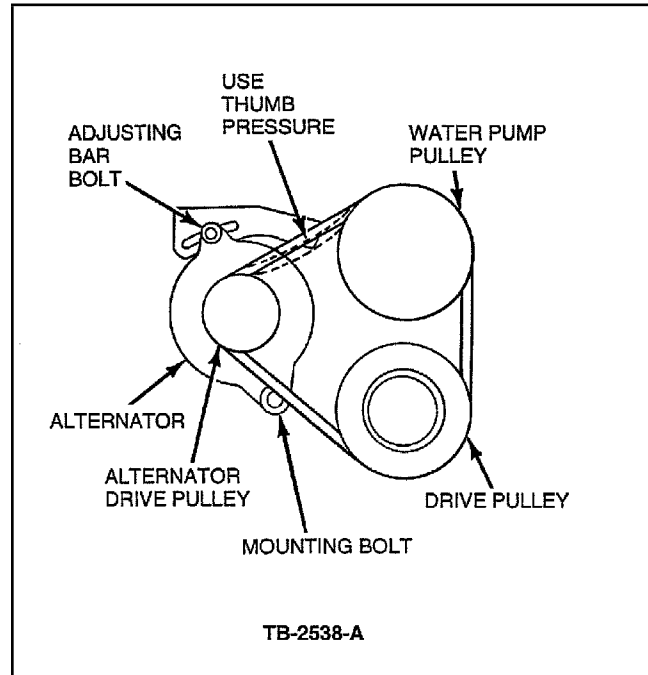
Figure 1 - Article 92-6-10

APPLY MODERATE THUMB PRESSURE (ABOUT 22 LBS., 10 KG) MIDWAY BETWEEN THE ALTERNATOR DRIVE PULLEY AND THE WATER PUMP PULLEY, FIGURE 1. CHECK THE DEFLECTION PER THE FOLLOWING ACCESSORY DRIVE BELT DEFLECTION CHART
