**FUEL SYSTEM—FILLER CAP SEPARATION—  
VEHICLES BUILT FROM JOB 1 TO 6/1/91**

**Article No.  
92-8-7**

**MERCURY:** 1991-1992 CAPRI

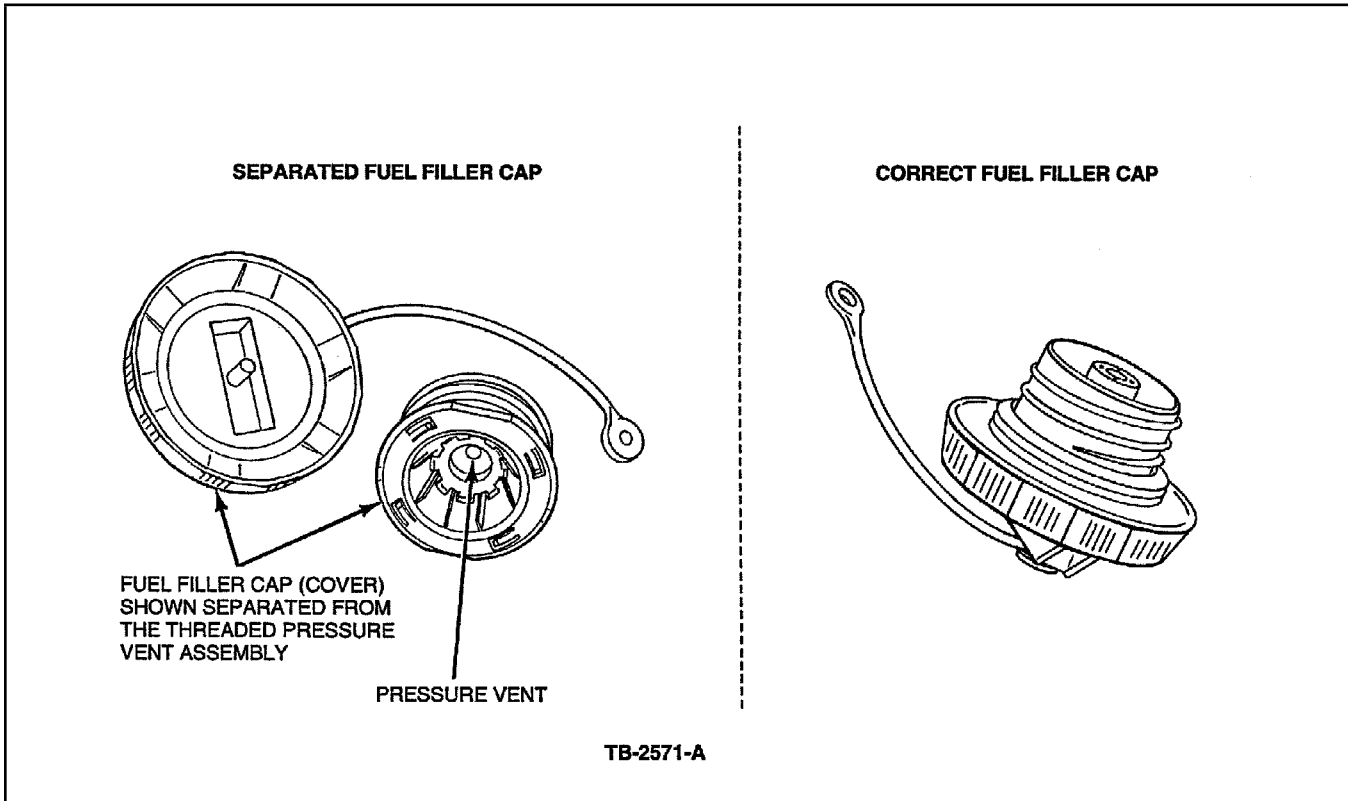
Figure 1 - Article 92-8-7

The fuel filler cap cover may separate from the threaded pressure vent assembly. If the cover separates from the threaded assembly, the seal and retaining threads may remain in the fill pipe and can be sealed by tightening.

**NO ATTEMPT SHOULD BE MADE TO MODIFY OR REASSEMBLE AN EXISTING FUEL FILLER CAP WHICH HAS SEPARATED. IF THE SEPARATION CONDITIONS OCCURS, REPLACE THE FUEL FILLER CAP ASSEMBLY WITH ONE WHICH HAS A MANUFACTURING DATE STAMP AFTER MAY 7, 1991. REFER TO FIGURES 1 AND 2.**

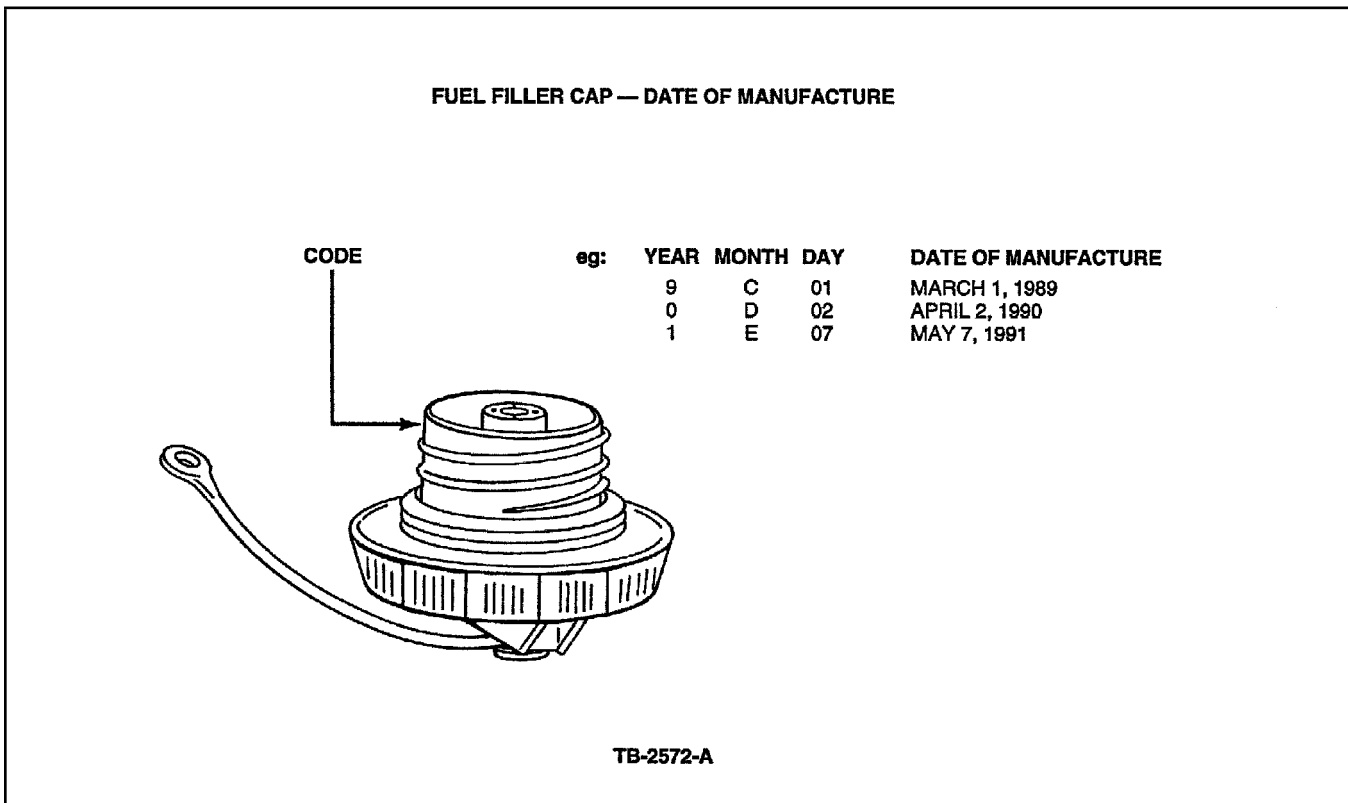
Figure 2 - Article 92-8-7

**ALL FUEL FILLER CAPS ARE DATE STAMPED AT THE BASE OF THE CAP INDICATING YEAR,**

**MONTH AND DAY OF MANUFACTURE. REFER TO FIGURE 2 FOR IDENTIFICATION.**
