**LEAKS—WATER—FRONT WINDOW CHANNEL
WEATHERSTRIP—VEHICLES BUILT FROM 10/26/91
THROUGH 7/23/92**

**Article No.
93-15-3**

MERCURY: 1991-1992 CAPRI

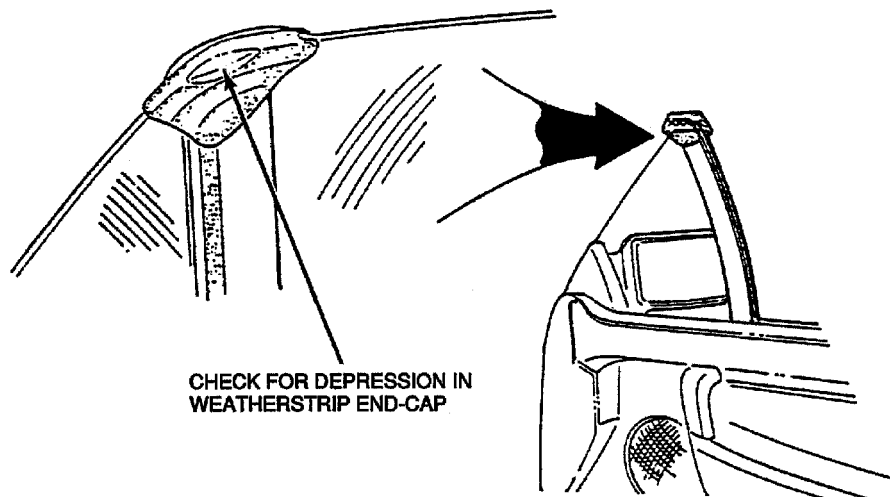
Figure 1 - Article 93-15-3

Water leaks at the front window channel may be caused by compressed weatherstrip end-cap mouldings. This can occur when vehicles are stored for an extended period of time.

1. Open door and inspect weatherstrip end caps for any signs of depression. Refer to Figure 1.

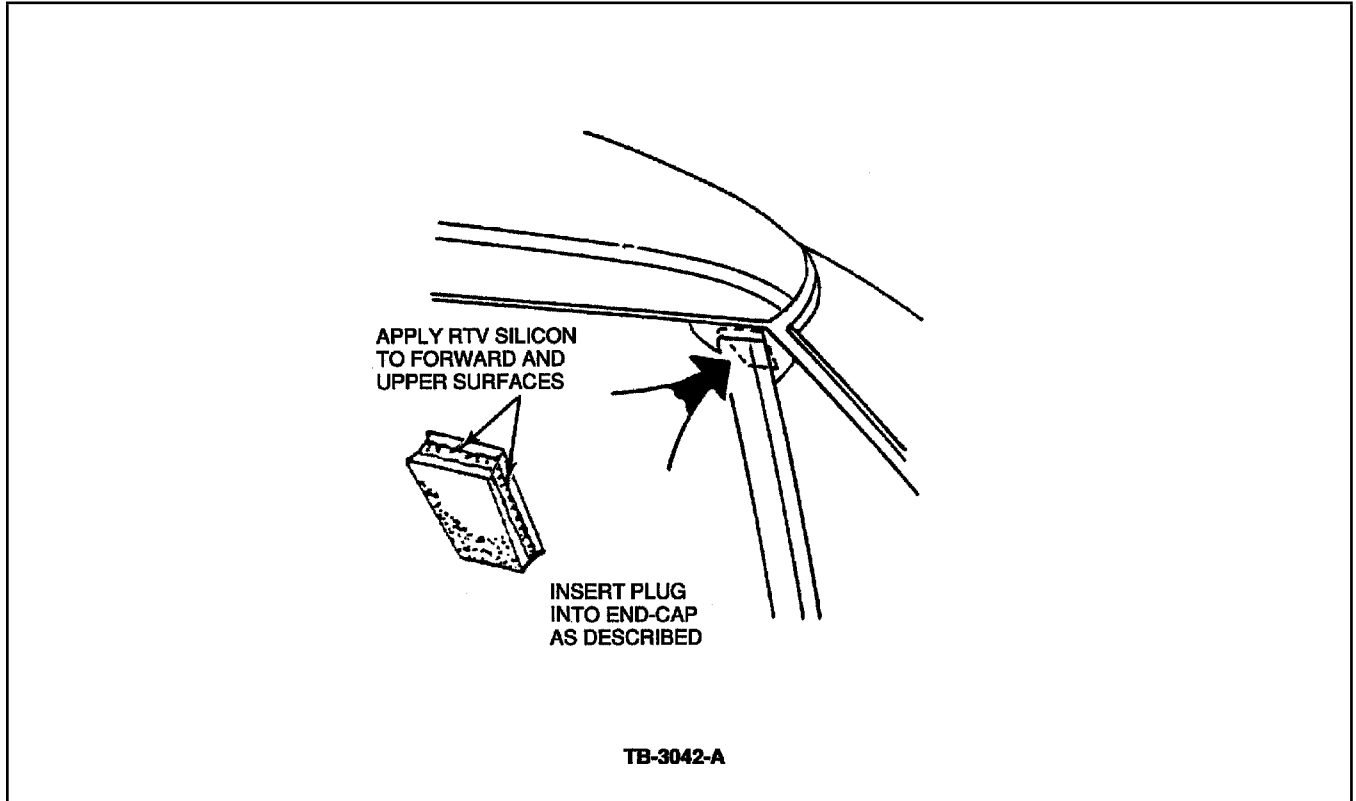
Figure 3 - Article 93-15-3

On vehicles which do not have a rubber plug fitted inside the weatherstrip end-cap, as shown in Figure 3, and which exhibit the water leak concern, perform the following repair procedure.

5. Using a flat bladed screwdriver, insert plug (F3JY-76229A12-A) into the window channel and force upward into the weatherstrip end-cap. Refer to Figure 3.
6. Completely raise door glass. This will properly position the plug in the door glass channel.
7. Repeat above procedures on opposite side of vehicle.
8. Water test vehicle to make sure acceptance standard is met. If water leak condition still exists, inspect windshield header weatherstrip and front side rail weatherstrips. Apply water leak repair procedures as required.
