FUSE—WINDSHIELD WIPERS—BLOWS IN FREEZING TEMPERATURES

Article No.
93-20-7

MERCURY: 1991-1993 CAPRI

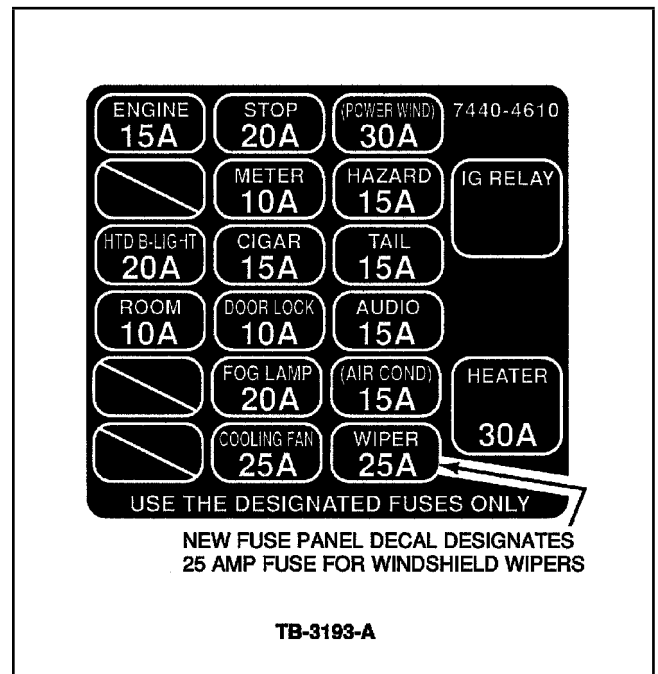
Figure 1 - Article 93-20-7

The “wiper” fuse may electrically blow when attempting to operate the windshield wipers while the wipers blades are frozen to the glass.

1. Replace the “wiper” fuse (15 amp or 20 amp) with a 25 amp fuse (D9ZZ-14526-F).
2. Replace the interior fuse panel decal with a new decal (F1JY-14A003-A) which designates a 25 amp fuse for the windshield wipers, Figure 1.
