**SPEEDOMETER—INOPERATIVE OR INACCURATE—  
CABLE DAMAGED—VEHICLES BUILT BEFORE  
7/23/90**

**Article No.  
92-13-9**

**MERCURY: 1991 CAPRI**

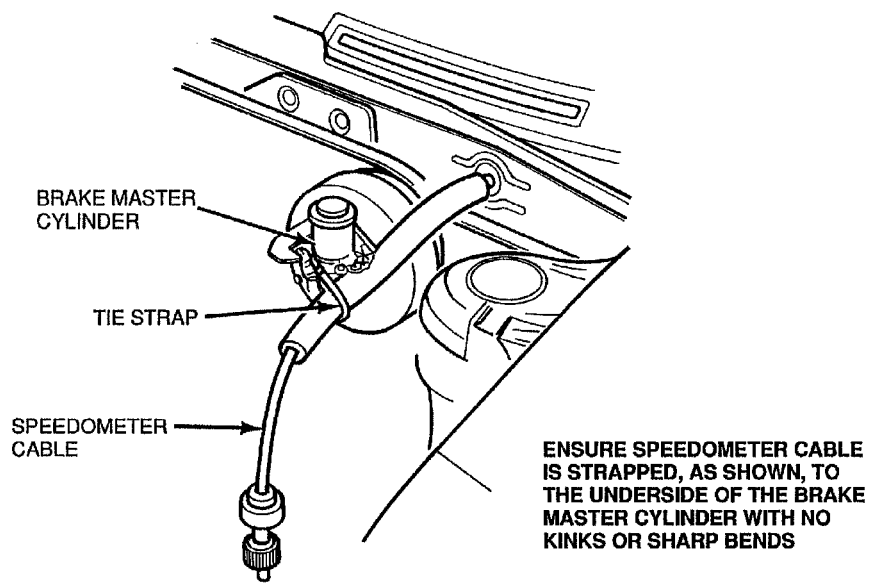
Figure 1 - Article 92-13-9

An inoperative or inaccurate speedometer may be caused by a speedometer cable that is kinked or broken.

**TORQUE SPEEDOMETER CABLE CONNECTION AT TRANSAXLE TO 3-5 LBS.-FT. (4-7 N•m).**

4. Reroute speedometer cable. Refer to Figure 1.
5. Secure the speedometer cable to the brake master cylinder with a tie strap. Refer to Figure 1.
