- **LOCKS—IGNITION—DEALERSHIP CUT KEYS DO NOT WORK IN IGNITION—ROTUNDA KEY BLANKS SOLD PRIOR TO 3/1/91**
- **IGNITION SWITCH—DEALERSHIP CUT KEYS DO NOT WORK IN IGNITION—ROTUNDA KEY BLANKS SOLD PRIOR TO 3/1/91**

**Article No.  
92-5-3**

**MERCURY:** 1991-1992 CAPRI

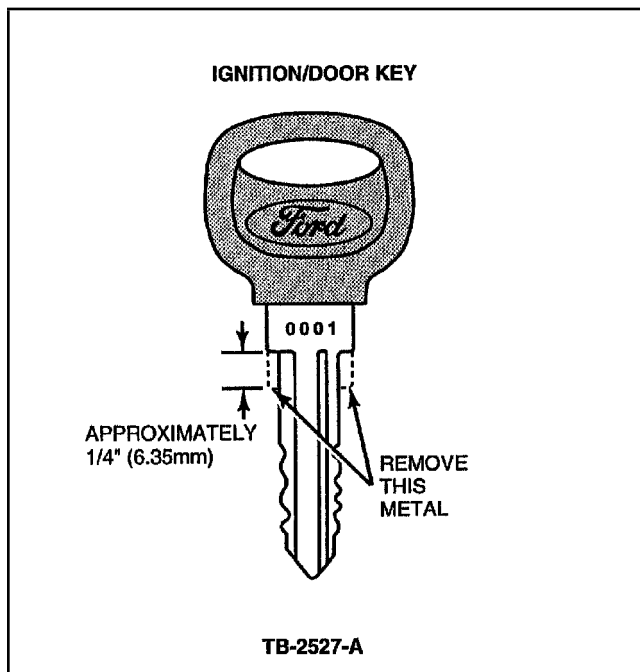
Figure 1 - Article 92-5-3

Some dealership-cut ignition keys may open the doors but not engage the ignition, thus preventing the car from starting. This is caused by a shoulder on the blade of the key blank #011-00155, Figure 1.

Remove the excess metal from the key blade, as shown in Figure 1. Use a file or key duplicator. To order key blanks, call the Rotunda Hotline: 1-800-762-6181 (Rotunda Dealership Supplies - Option 2).
