MERCURY: 1991-1993 CAPRI

Water leaks around the “A” pillar area may be caused by the windshield header weatherstrip.

Article No. 94-7-3 Cont'd.

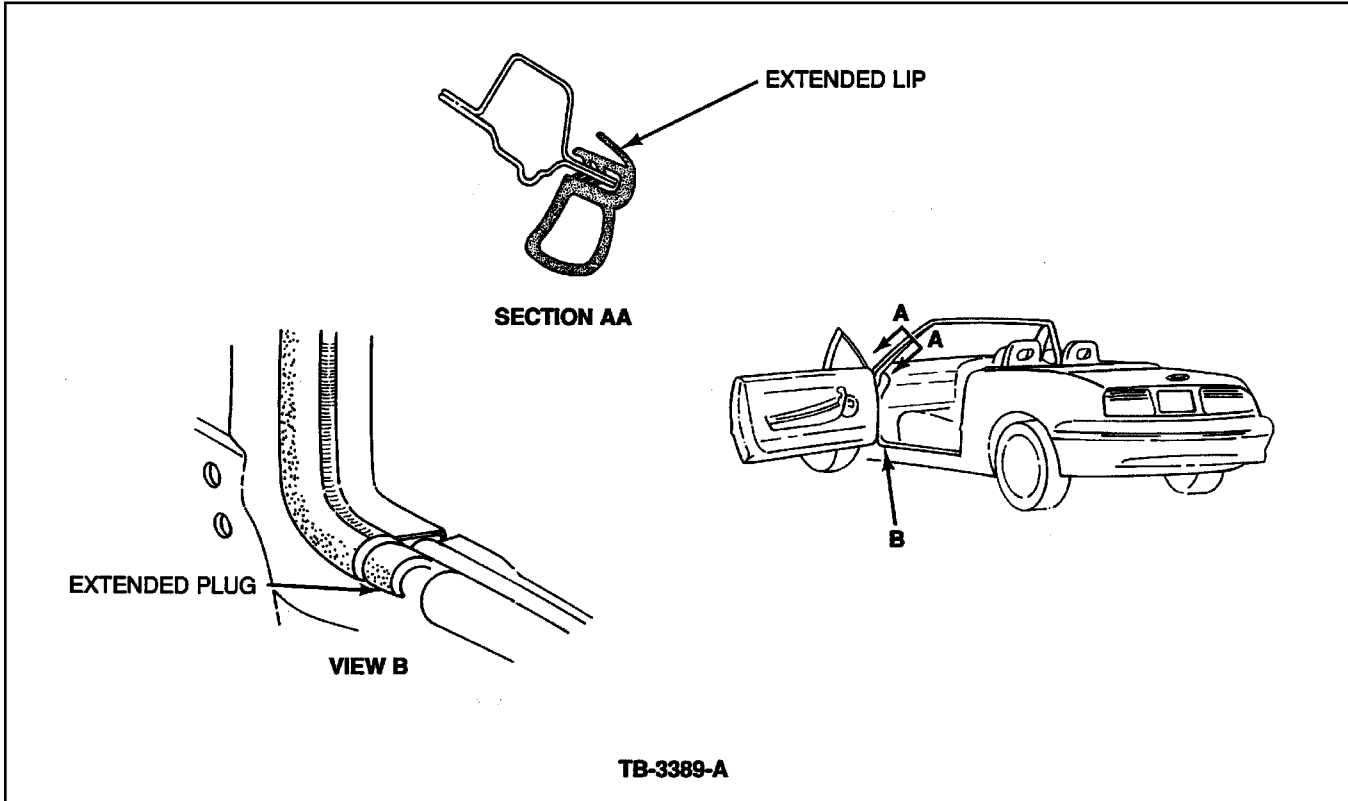
Figure 1 - Article 94-7-3

The new level windshield header weatherstrip provides improved sealing with the following features, Figure 1:

- An extended trim lip along the “A” pillar section to eliminate gaps
- An extended plug in the ends of the weatherstrip (where the weatherstrip joins to the door weatherstrips) to eliminate water leakage caused by weatherstrip “puckering”

A revised windshield header weatherstrip is now available which will provide improved sealing in the “A” pillar area.

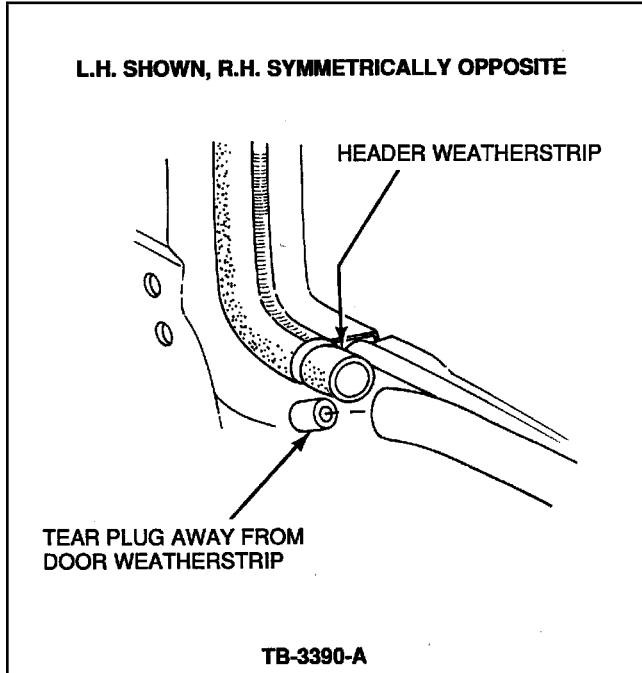
Figure 2 - Article 94-7-3

1. Remove the header weatherstrip.
2. Tear plug away from the ends of door weatherstrips, Figure 2.
3. With the windshield header weatherstrip removed:
 - a. Peel away any double-sided tape from the horizontal and vertical faces of the windshield moulding.

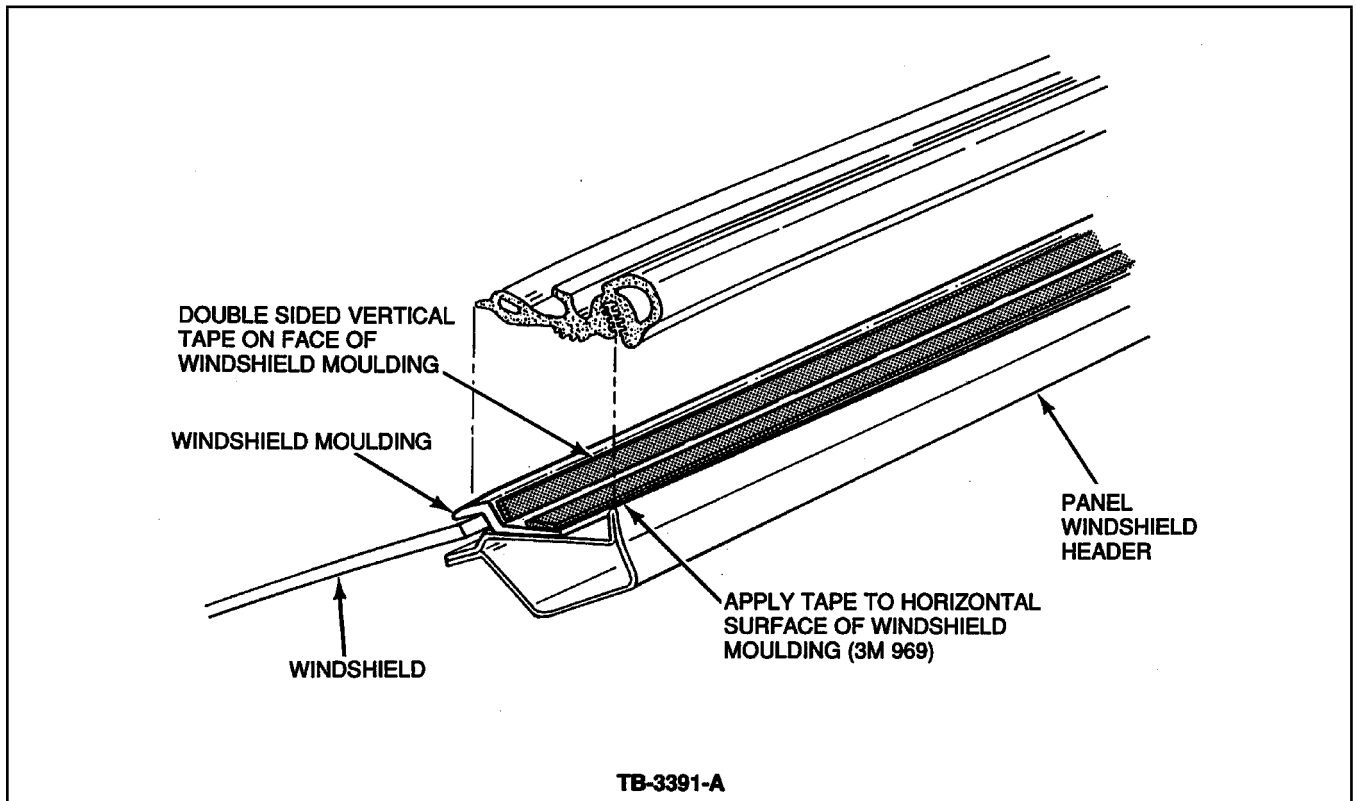
Figure 3 - Article 94-7-3

4. Apply the new tape (F2JY-76514-A46S) to the front vertical face of the windshield upper moulding. Press tape firmly to ensure full contact. **DO NOT** remove pull tape.
5. Apply a strip of 3M Brand '969' adhesive tape (FOJY-76514-A46A, or equivalent) along the length of the horizontal face of the windshield upper moulding. Do not peel the backing paper from the tape, Figure 3.
